The Cyclopath

W.D.M. Limited, has called on its unrivalled experience of testing the surfaces of UK roads to develop a specialist machine to check the safety of cycle ways.

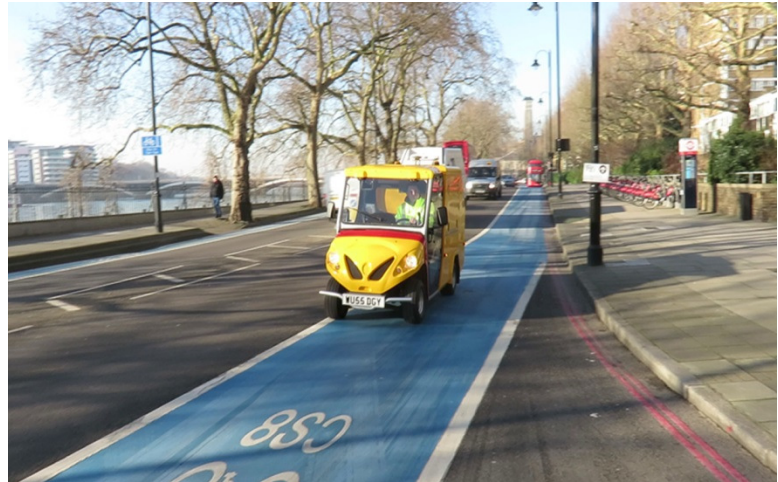
The Cyclopath uses tried and tested laser technology to scan the surface of cycle paths to check for rutting, texture depth, changes in the transverse profile and any cracking. It has successfully completed trials in the West Country and in London and is based on proven technology.

The Cyclopath not only records the condition of cycle ways, but is fitted with a forward facing video to produce a visual record of the route being checked. It also comes equipped with GPS to enable local authorities and other stakeholders to produce an accurate map of the network.

The Cyclopath has a forward facing camera capturing an image every five metres of forward travel during a survey. Images are 1280 x 768, 24bit RGB colour compressed Jpegs, saved as a Windows AVI file. Other technical specifications:

Longitudinal surface texture obtained by laser height measurements using 1mm sampling

Inertial longitudinal profile measurement (min speed 12 kph)

Continuous GPS location tracking +/-1m

Two metre wide transverse profile measurement sampled every 100mm (optional over 20mm) of forward travel. Profile measurement accuracy +/-1mm.

Single drive / survey operator controls system using 1U PC.
